THAMES RIVER BASIN  
COLCHESTER, CONNECTICUT

DEEP RIVER RESERVOIR DAM  
CT 00346

PHASE 1 INSPECTION REPORT  
NATIONAL DAM INSPECTION PROGRAM

MAY 1979

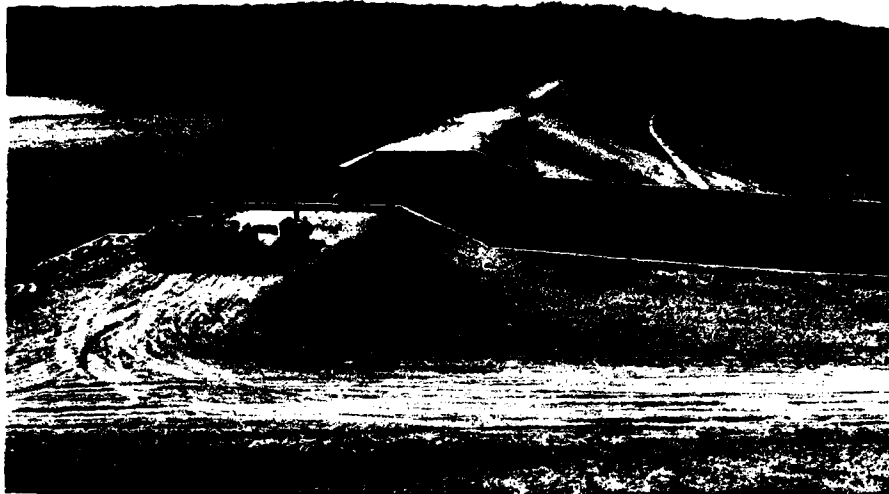
1. Crest. The crest of the dam is in good condition. The crest is covered with grass which is in good condition and well maintained and supports a service road as shown in Photo C-2, 3. There are no signs of erosion or wear on the crest.
2. Upstream Slope. The upstream slope of the dam is covered with riprap up to 3 ft. in diameter, except where the upper portion of the concrete core wall forms part of the upstream face as shown in Photo C-1. The riprap is in good condition as illustrated in Photo C-1, 2. The upstream slope is clear of vegetation.
3. Downstream Slope. The downstream slope is grass-covered and clear of other vegetation. A midslope berm intercepts surface runoff from the slope and channels it into the toe drain collection system located at the downstream toe as shown in Photos C-3, 4 and 5.

The downstream slope is in good condition. There are some minor erosion tracks about 2-3 in. wide and 1- to 2-in. deep, and some minor surface sloughing. In general, the erosion is minimal. See Photos C-3, 4, 5, and 13.

C-3 CREST AND DOWNSTREAM SLOPE FROM RIGHT ABUTMENT

Minor erosion on the main embankment should be repaired during maintenance landscaping activities.

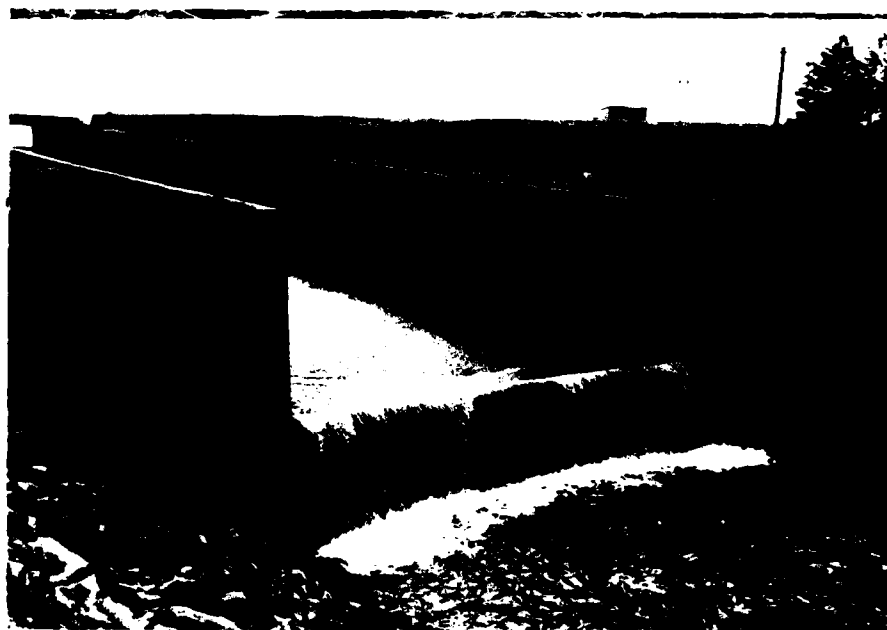
1. Spillway. The overflow spillway consists of a chute with concrete floor slab and training walls. The general configuration of the spillway is illustrated in Photos C-6, 7, 8, 16 and the overview photo. Water was overflowing the spillway at the time of inspection. Drain holes are located along the chute near the base of the training walls and in the headwall at the downstream end of the chute. At the time of inspection, one of the drain holes along the chute was discharging as noted in Photo C-7. Both weep holes in the downstream headwall were discharging as indicated in Photo C-8.

C-8 SPILLWAY DISCHARGE

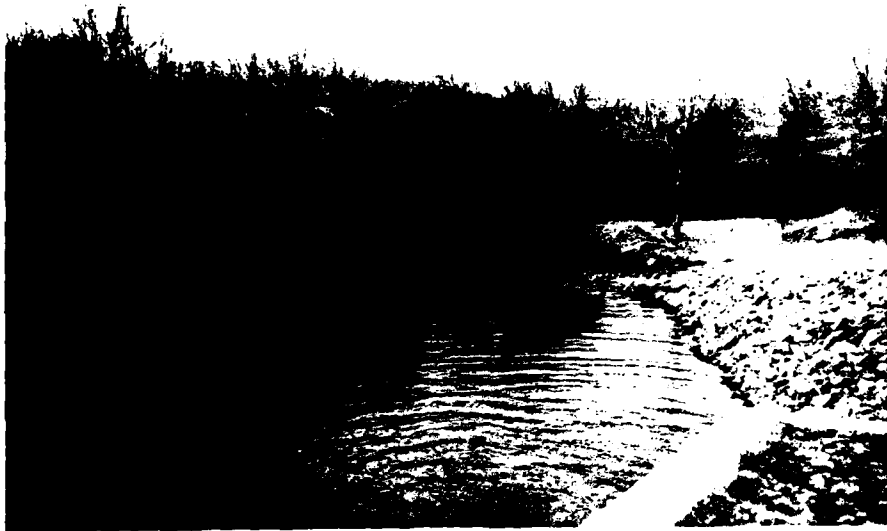
4. Pedestrian Access Bridge. Access to the main embankment from the easterly abutment area is by means of a prestressed concrete pedestrian bridge across the overflow spillway chute. This bridge was in good condition. See Photo C-16.
5. Utility Building. A utility building is located on the crest of the main embankment adjacent to the access bridge to the gatehouse. This building houses air compressors which operate aoxxygenating bubbler system in the reservoir to improve the quality of the water. This building is shown in Photo C-18.
- d. Downstream Channel. The downstream channel is naturally meandering and bordered by a wooded shoreline. No debris was noted, however, periodic inspection should be maintained to assure that it remains unobstructed. See Photo C-9.

C-9 SPILLWAY DISCHARGE CHANNEL LOOKING DOWNSTREAM

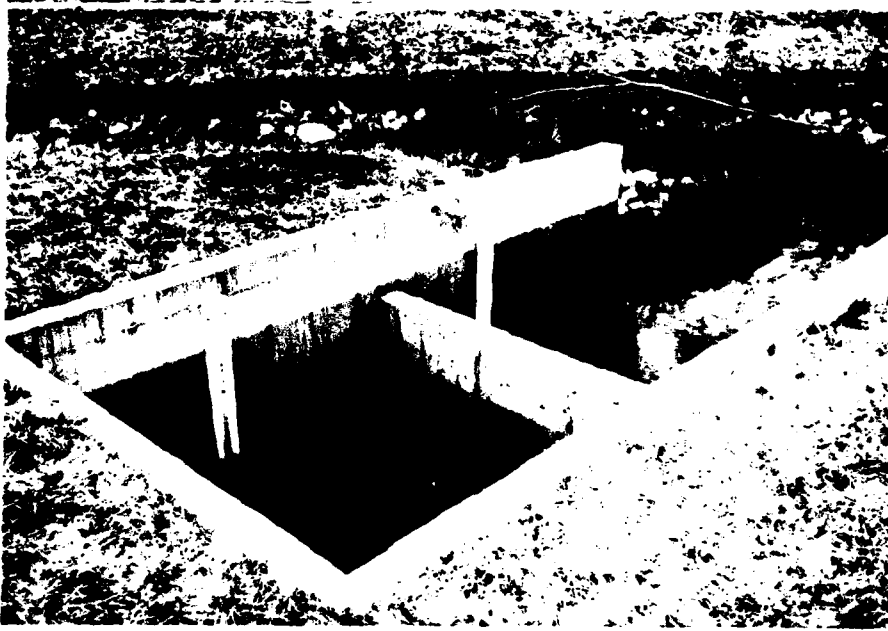
A considerable quantity of water was discharging from the toe drain outlet at the downstream toe into the toe drain collection ditch. The discharge appeared to be free of sediment. The quantity of discharge appeared to be great as shown in Photo C-13. The discharge at this location appears to be a major source of rust-colored staining which was noted in portions of the toe drain collection system. The cause of the staining is not known. The discharge from the drains at the downstream toe is channeled into two box weirs. Discharge from the relief wells is collected in a header pipe and channeled into a third weir box. The weir boxes appear to be too full in both chambers to measure the existing flow since little head difference across the weir opening could be observed. The weir openings were encrusted with a rust-colored floc. (See Photo C-15.)

C-15 WEIR BOX FOR SEEPAGE MEASUREMENT (1 of 3)

- a. The existing seepage flow weir boxes should be modified in order to better record the quantity of flows. It is suggested that V-notched weir plates be used as a replacement for the orifice plates in use at present. These readings should be obtained regularly and plotted so that a comparison can be made to denote any changed condition. Levels of the reservoir pool must also be recorded at the time of the seepage readings.
- b. The erosion of the embankment immediately upstream from the left abutment of the main dam must be repaired. Consideration should be given to extending stone armor

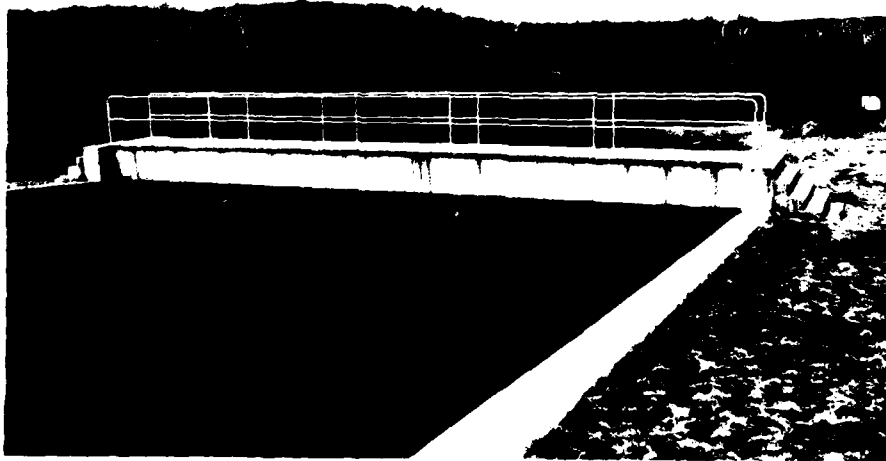
C-16 SERVICE BRIDGE ACROSS SPILLWAY
